**USAAVLABS TECHNICAL REPORT 67-83**

**AN EVALUATION OF CONFORMAL CONTACT GEARS**

**U. S. ARMY AVIATION MATERIEL LABORATORIES**  
**FORT EUSTIS, VIRGINIA**  
**CONTRACT DA 44-177 AMC-389(T)**  
**THE BOEING COMPANY**  
**VERTOL DIVISION**  
**PHILADELPHIA, PENNSYLVANIA**

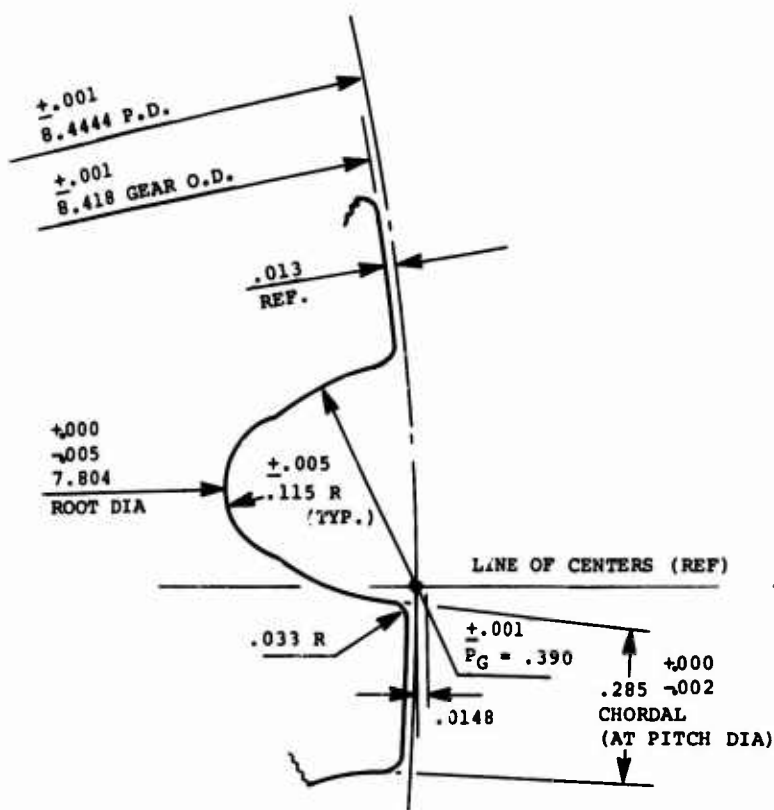
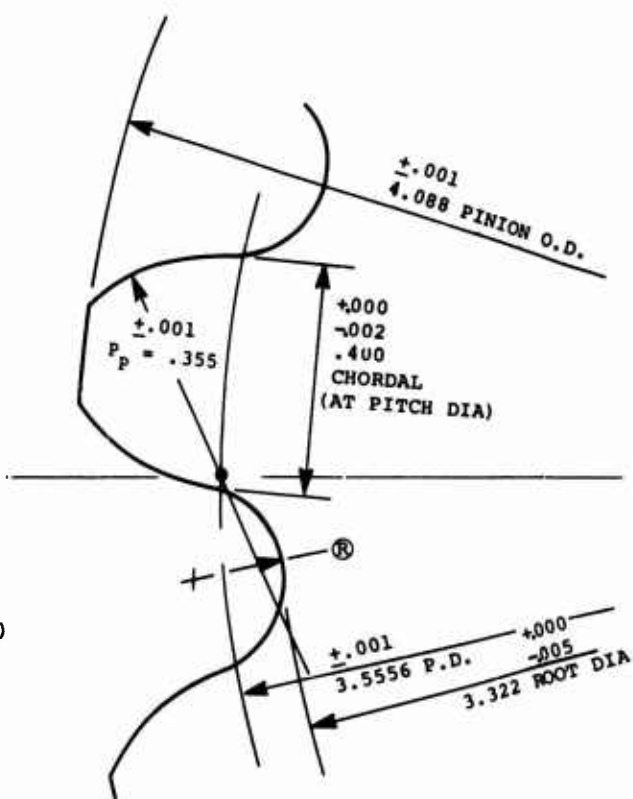
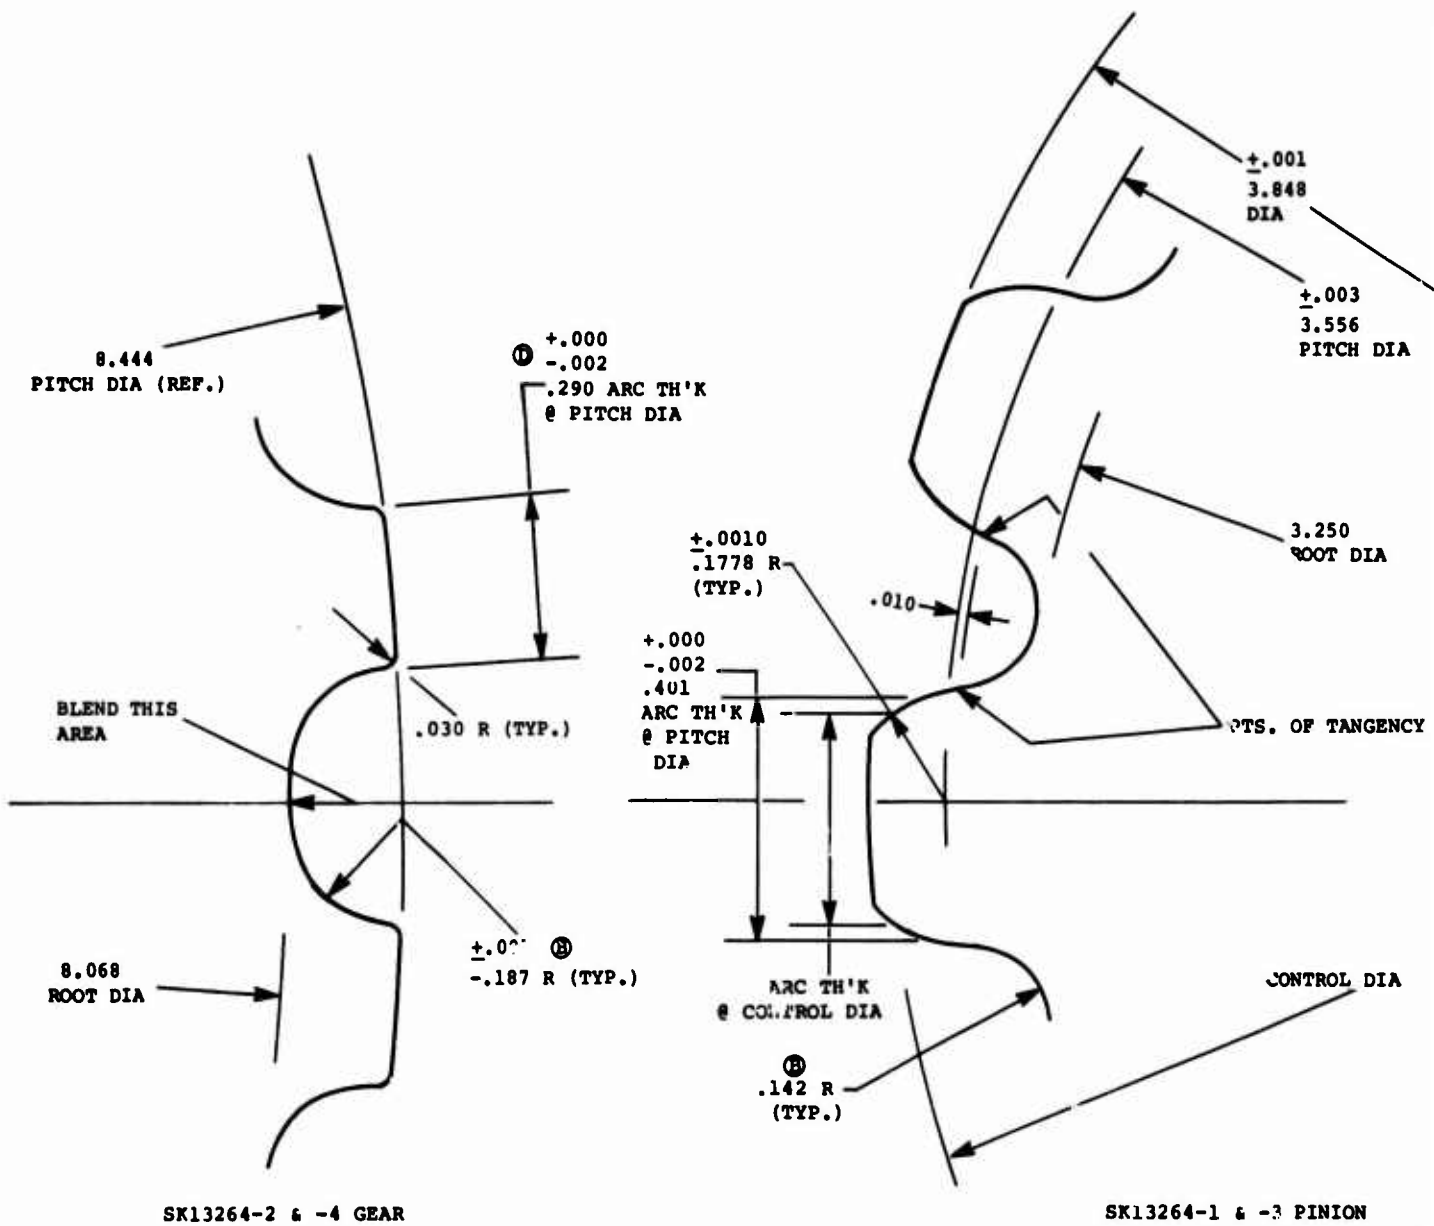
Figure 2. Comparison of Geometry of SK16207 Test Gears With SK13264 Test Gears.

SK16207-4 GEAR

SK16207-3 & -7 PINION

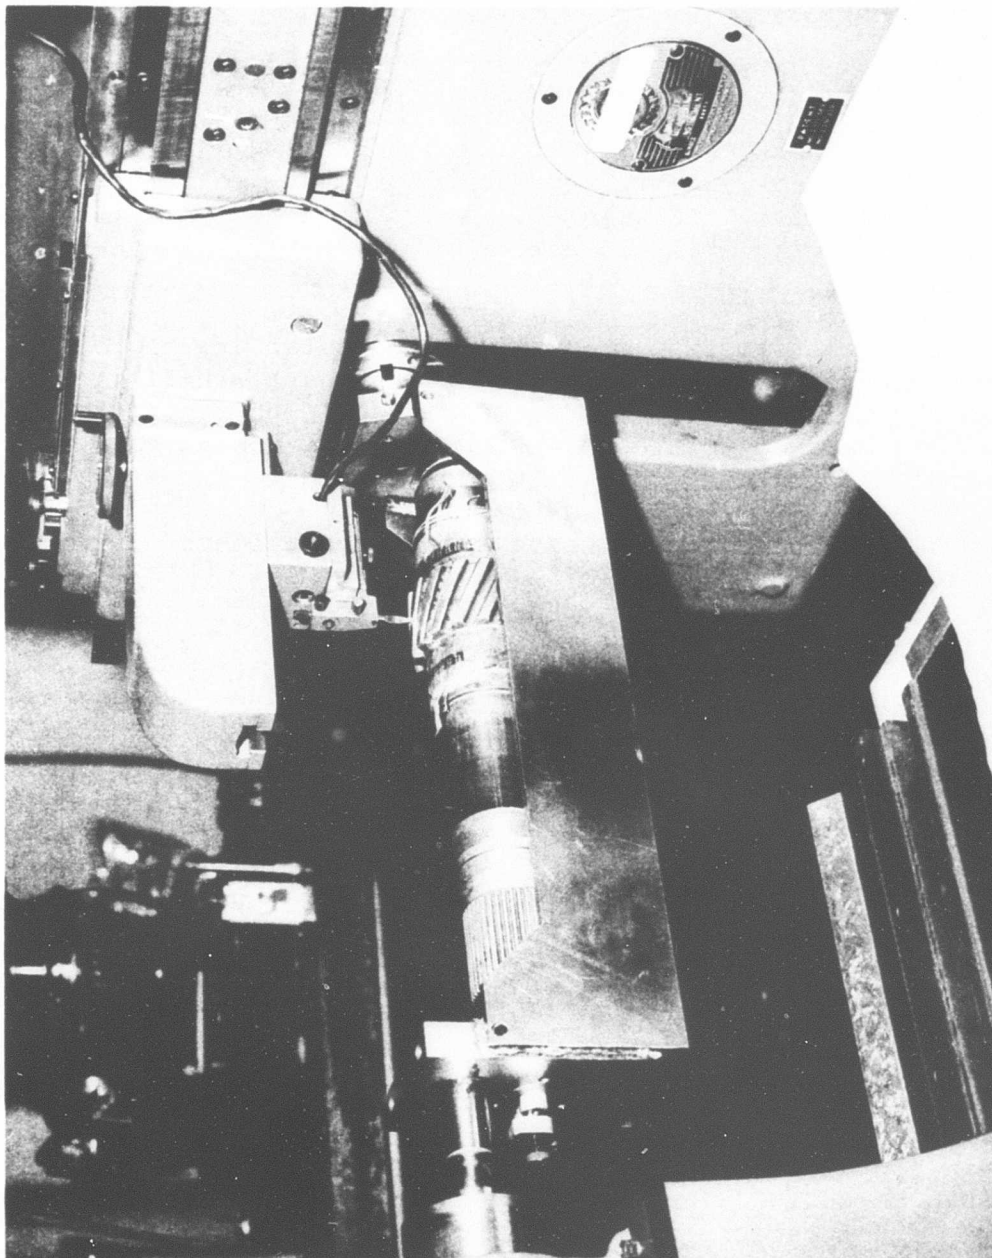
Figure 3. Offset Pinion Fixture for Involute Measuring Instrument.

To demonstrate the feasibility of circular arc profile inspection, an offset gear fixture was developed for the convex pinion member for use on a standard involute measuring instrument. A special pointer (stylus) is required which has a 0.0005-inch-radius diamond for contacting the profile. (Refer to Figure 3.) The primary purpose of the fixture is to position the conformal pinion in both a radial and a tangential

direction so as to permit rotation about the center of the profile radius while the fixture is mounted between the center of the involute measuring instrument. The generating action of the instrument is locked out by setting the base circle radius to zero.

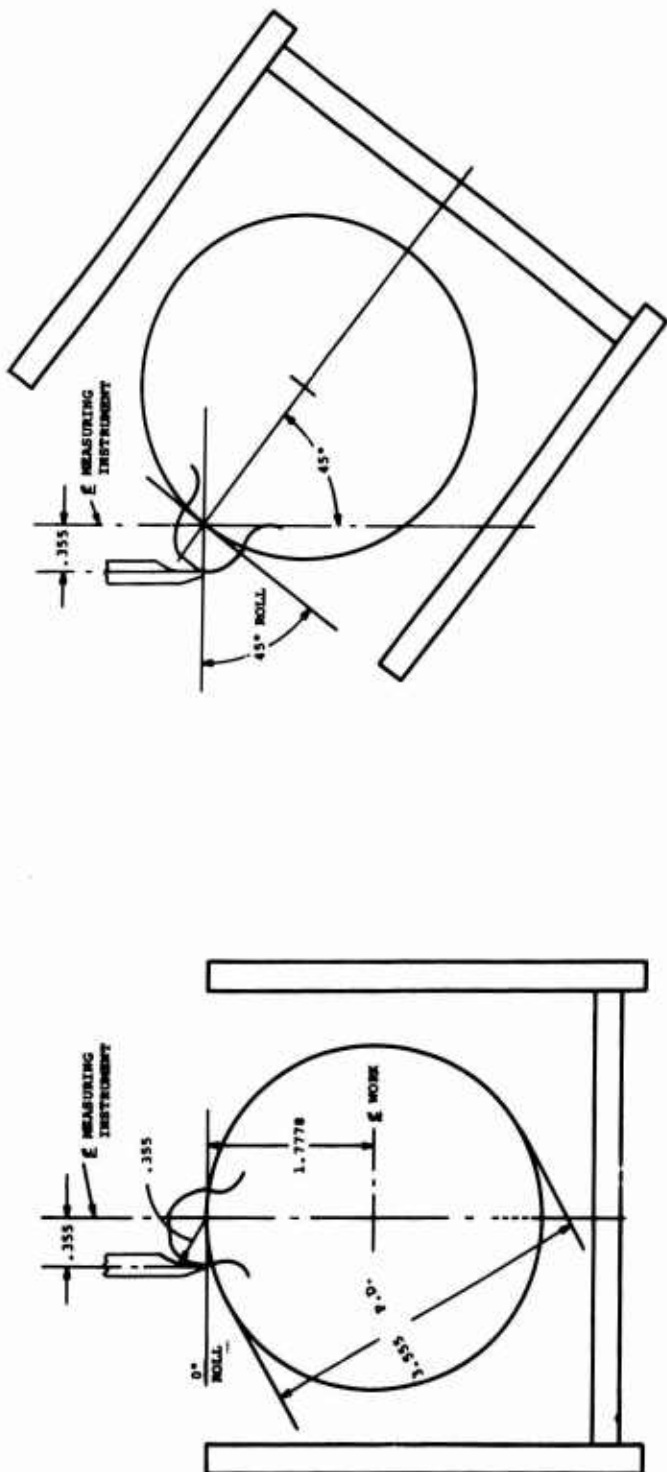
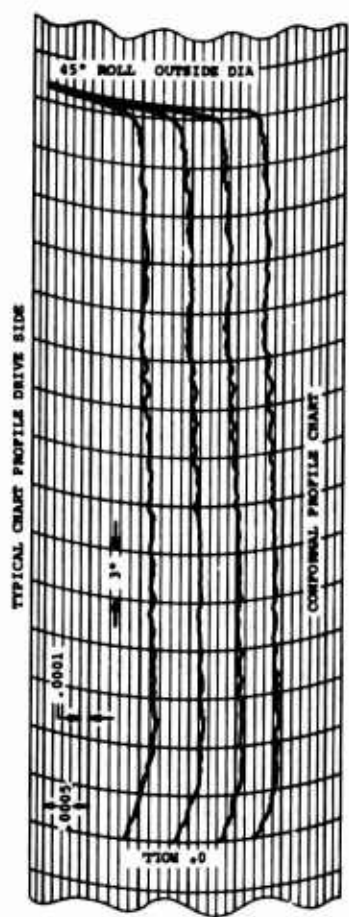
Figure 4. Pinion Offset Fixture - Principle of Operation.

The tooth helix angle of conformal gear limits direct inspection of the tooth profile to the ends of the gear face, and edge breaks or rounding distorts the resulting projected image. Both of these limitations can be overcome by the use of indirect methods which are subject to limited accuracy, as explained above.

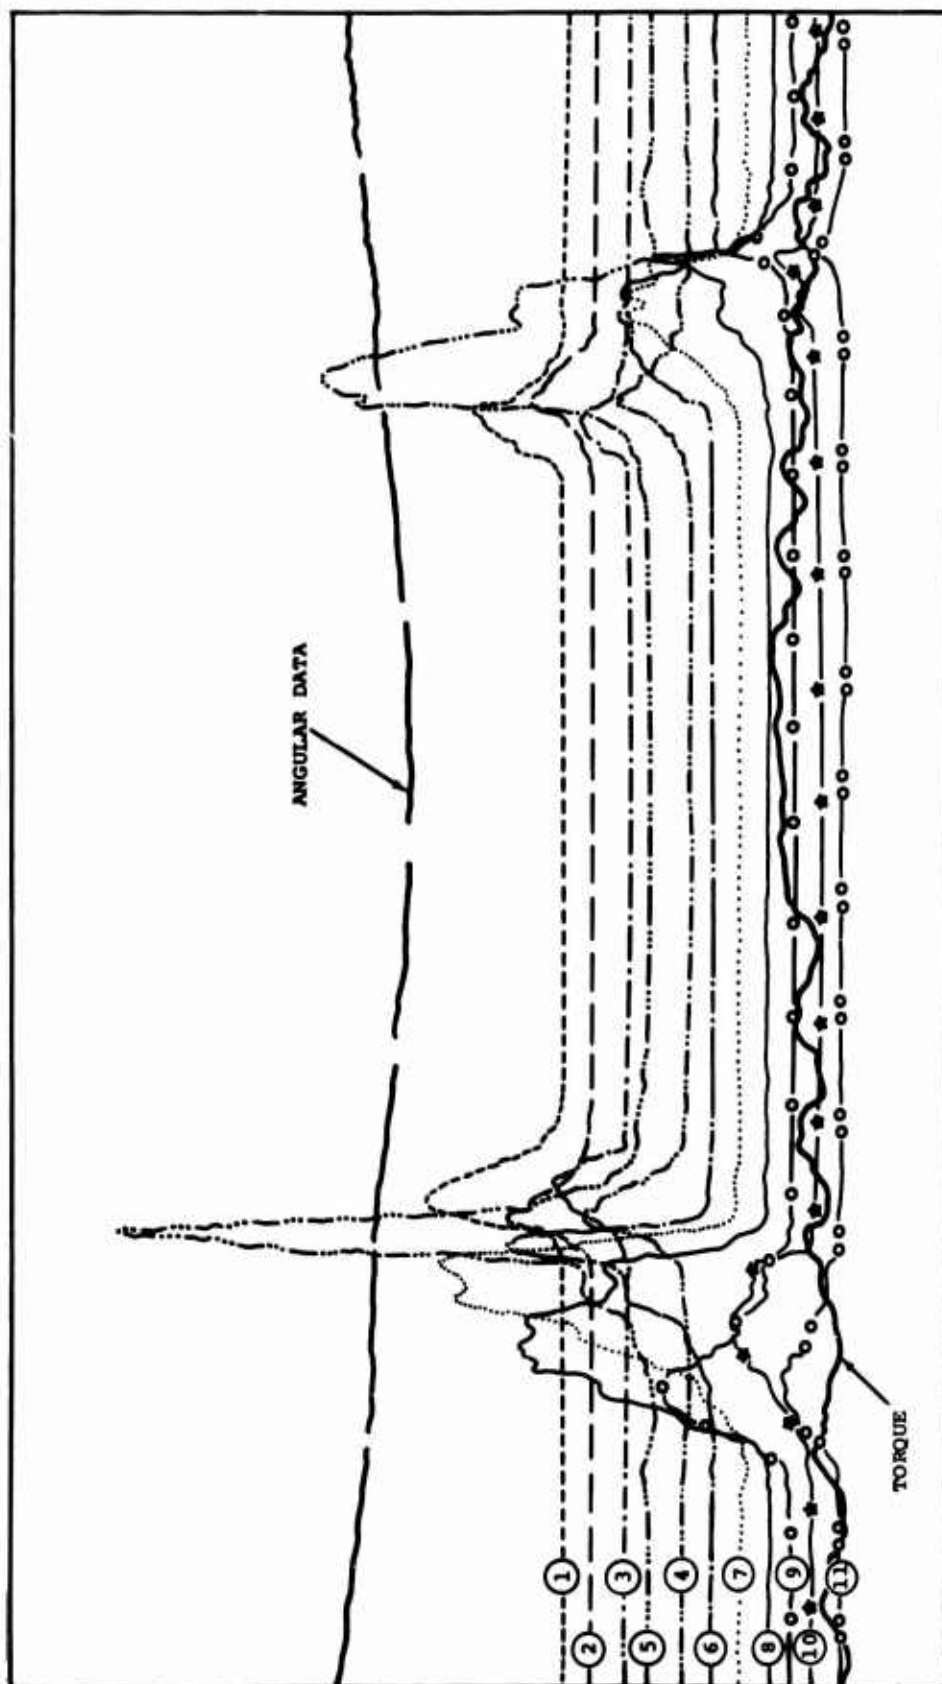
Figure 8. Oscilloscope Record of Strain Gage Data.

A typical record of test results is shown in Figure 8. Outputs of gages 1 through 11 are shown as they rise and fall during the meshing cycle. The middle tooth is in mesh from the first rise of gage 9 to the return to zero of gage 3. The return to zero of gage 10 indicates the instant of disengagement of the first tooth. The rise of gage 2 indicates the engagement of the third tooth. The interim period is when the middle tooth carries all the load. The period of single-tooth engagement was found to be of very short duration (Figure 9).

The left-hand peaks were obtained with the pinion driving; the right-hand peaks were obtained in reverse with the gear as the driving member. During the meshing cycle, strain amplitudes were found to be consistently higher with the pinion driving. This result is in agreement with the testing accomplished in USAAVLABS Technical Report 66-8.

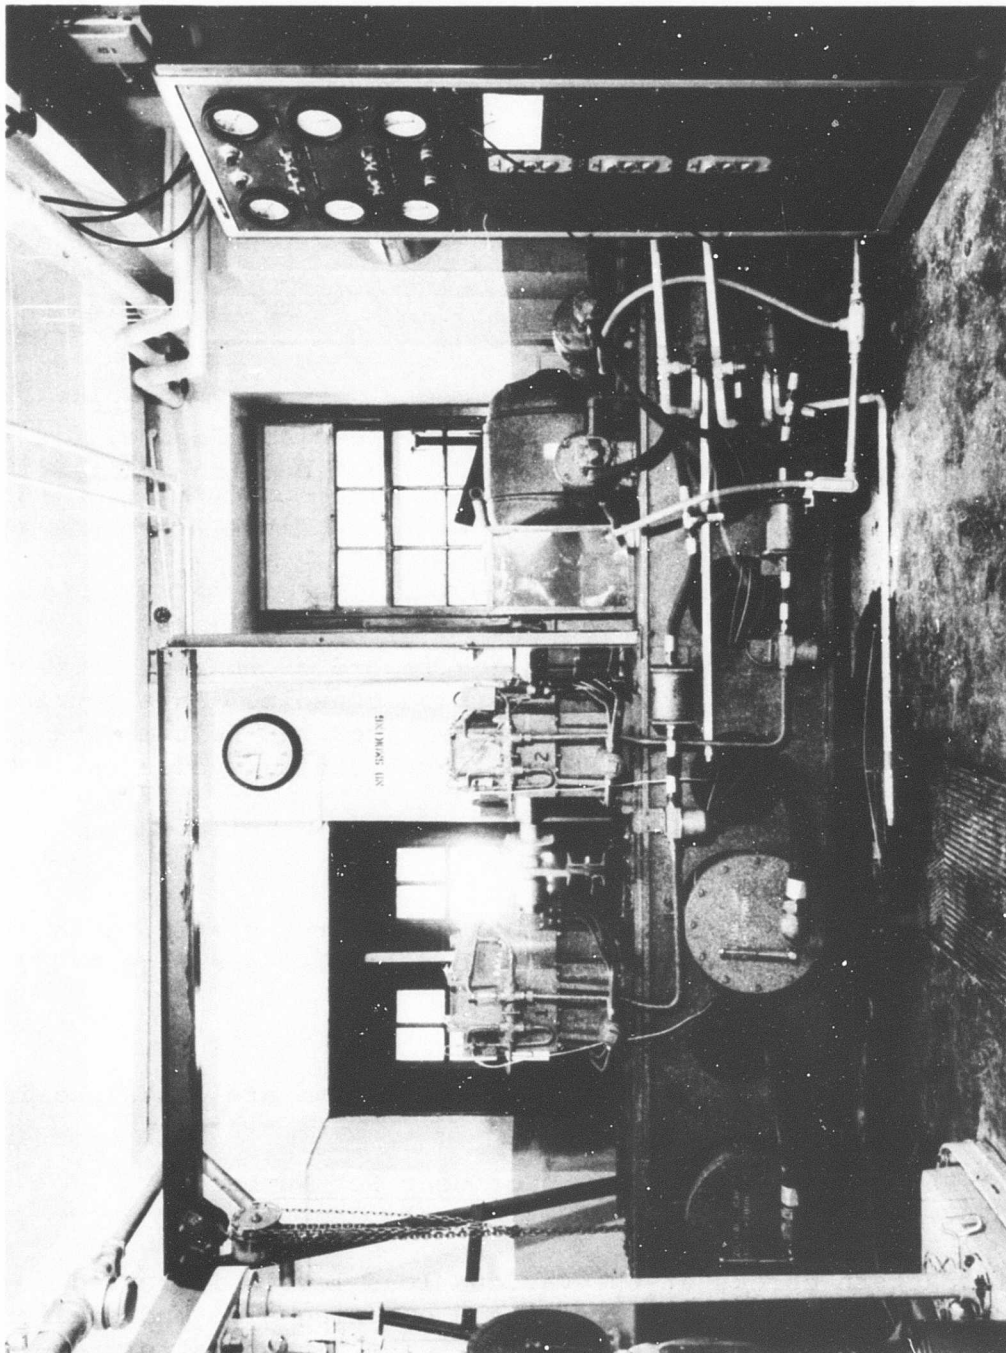
Figure 12. Gear Research Test Stand.

Testing was conducted in a Vertol Division-owned regenerative (four-square) load test stand built specifically for gear research (see Figure 12). The two gear housings are designed to be rigid and stable under all loading conditions. Housings were through-bored for maximum accuracy. Torque, rpm, and lubrication can be varied over a wide range.

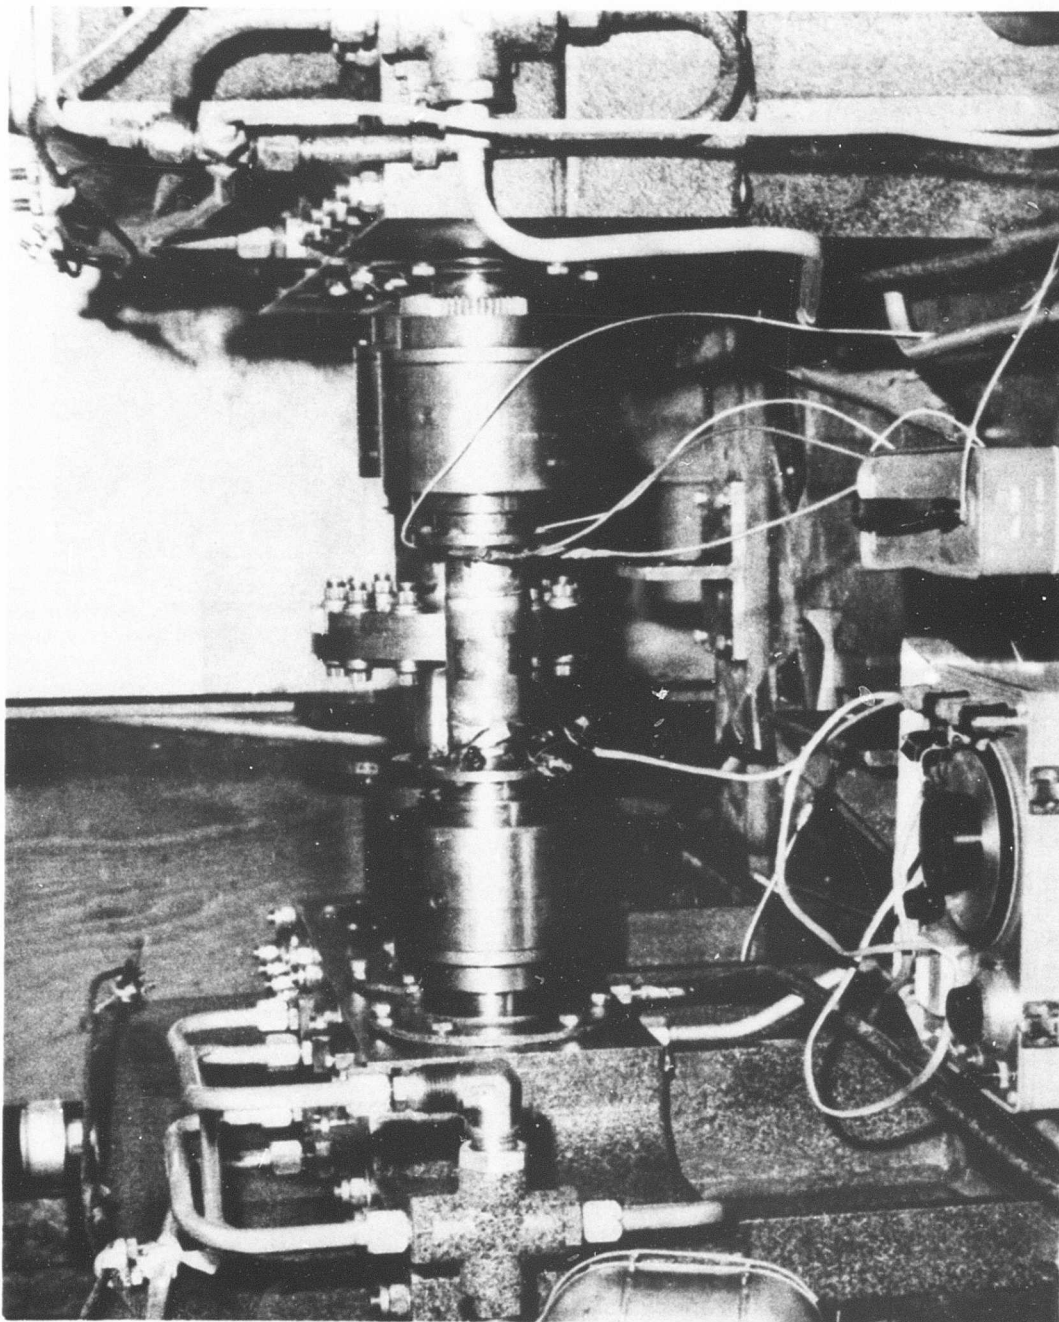
Figure 13. Test Stand Torquemeter Installation.

Torque was applied with a lever system at the beginning of each test run. Torque levels were observed on a Strainert instrument (see Figure 13). The procedure for this test program was to check torque after 30 minutes of running, then to recheck every 4 hours during the test. Deviation from the initial target torque was held to  $\pm 5$  percent.

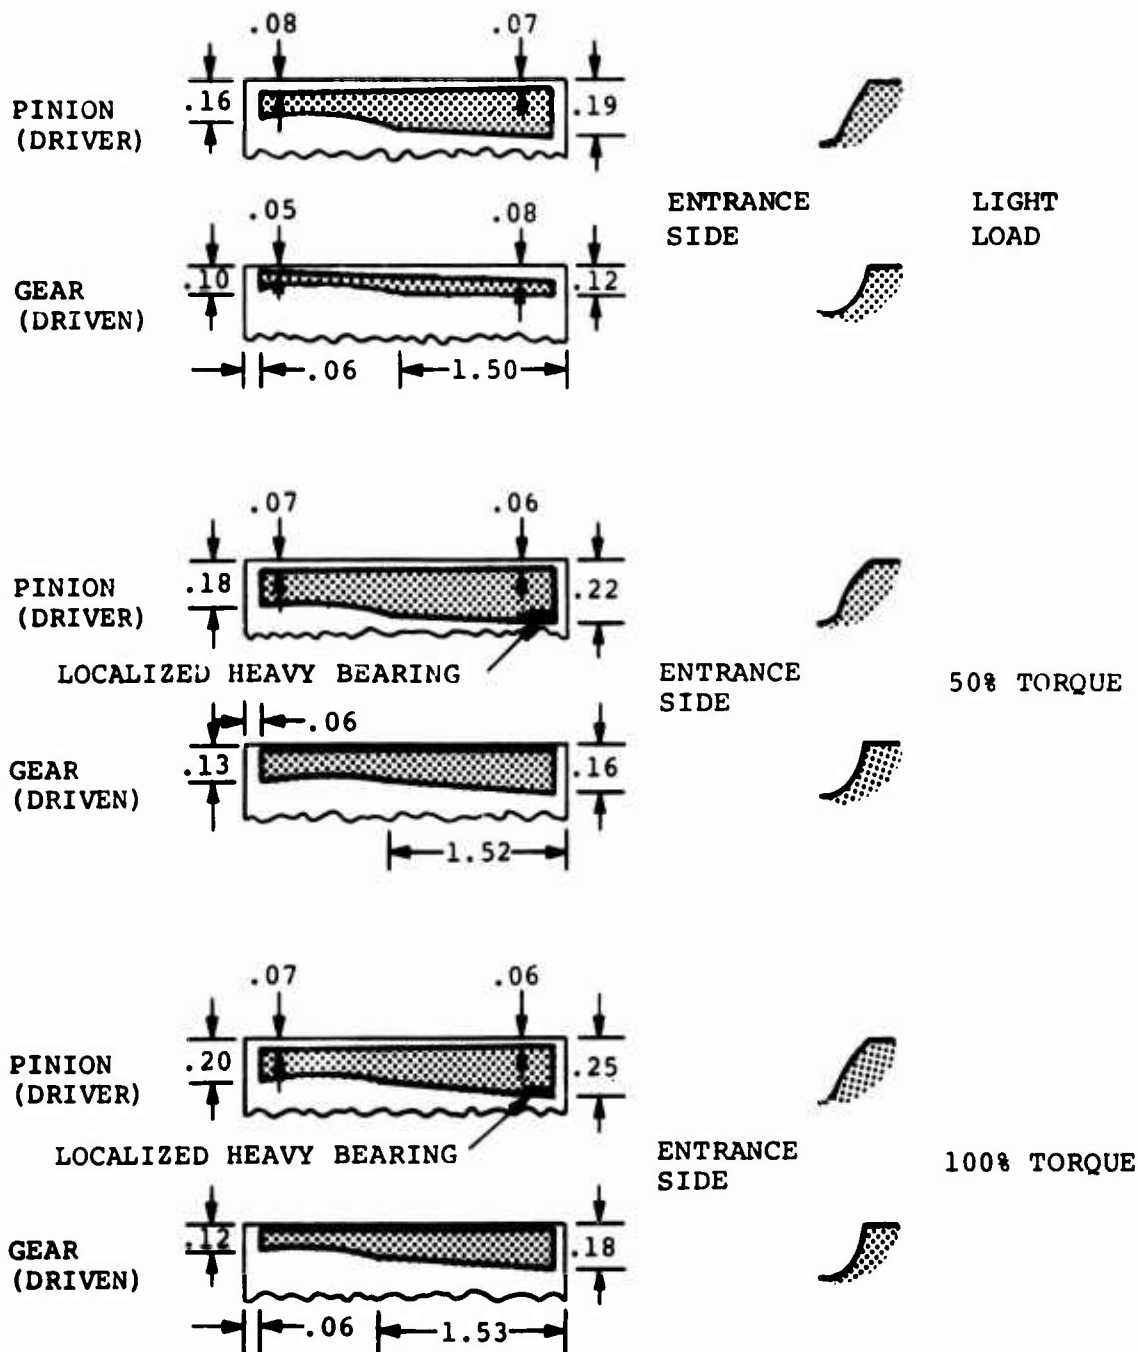
Figure 16. Static Gear Patterns - Gear Set No. 1.

Static pattern checks at the various load levels indicated a tapered tooth pattern, larger at the entering side and smaller at the exiting side (see Figure 16). The pinion pattern extended further down the tooth flank than did the gear pattern. The gear tooth pattern was at or beyond the break edge radius

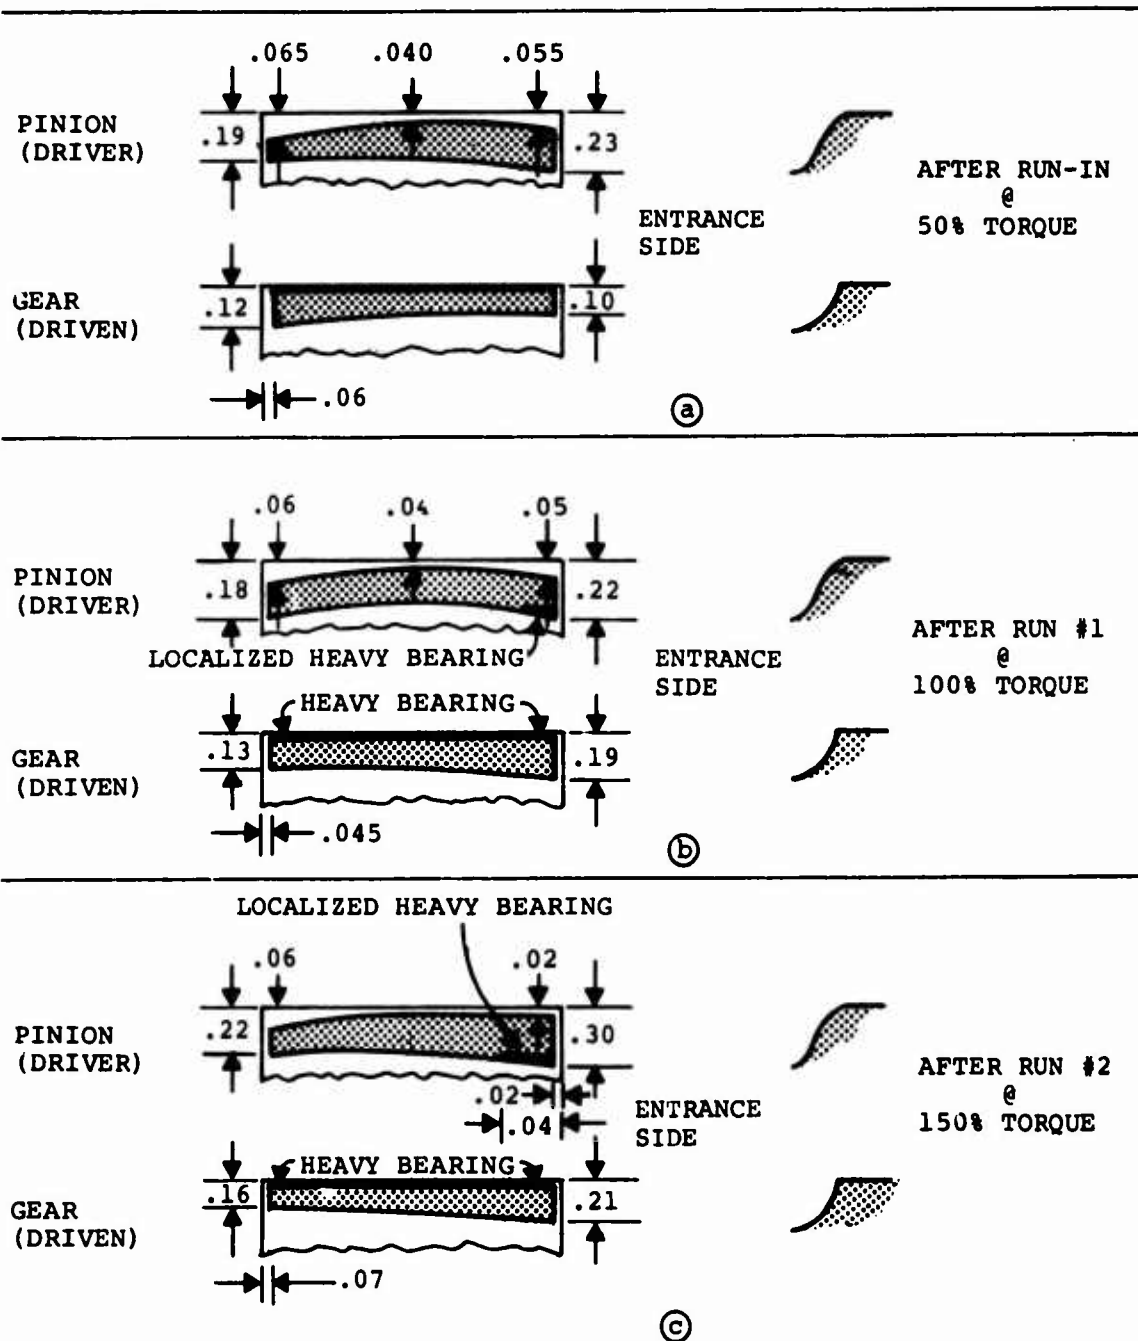
Figure 17. Gear Patterns After Running - Gear Set No. 1.

at the outside diameter, at the higher load levels. Visual inspection after the initial run-in (at 50 percent of the design load) did not reveal any adverse conditions in regard to surface distress (see Figure 17a).

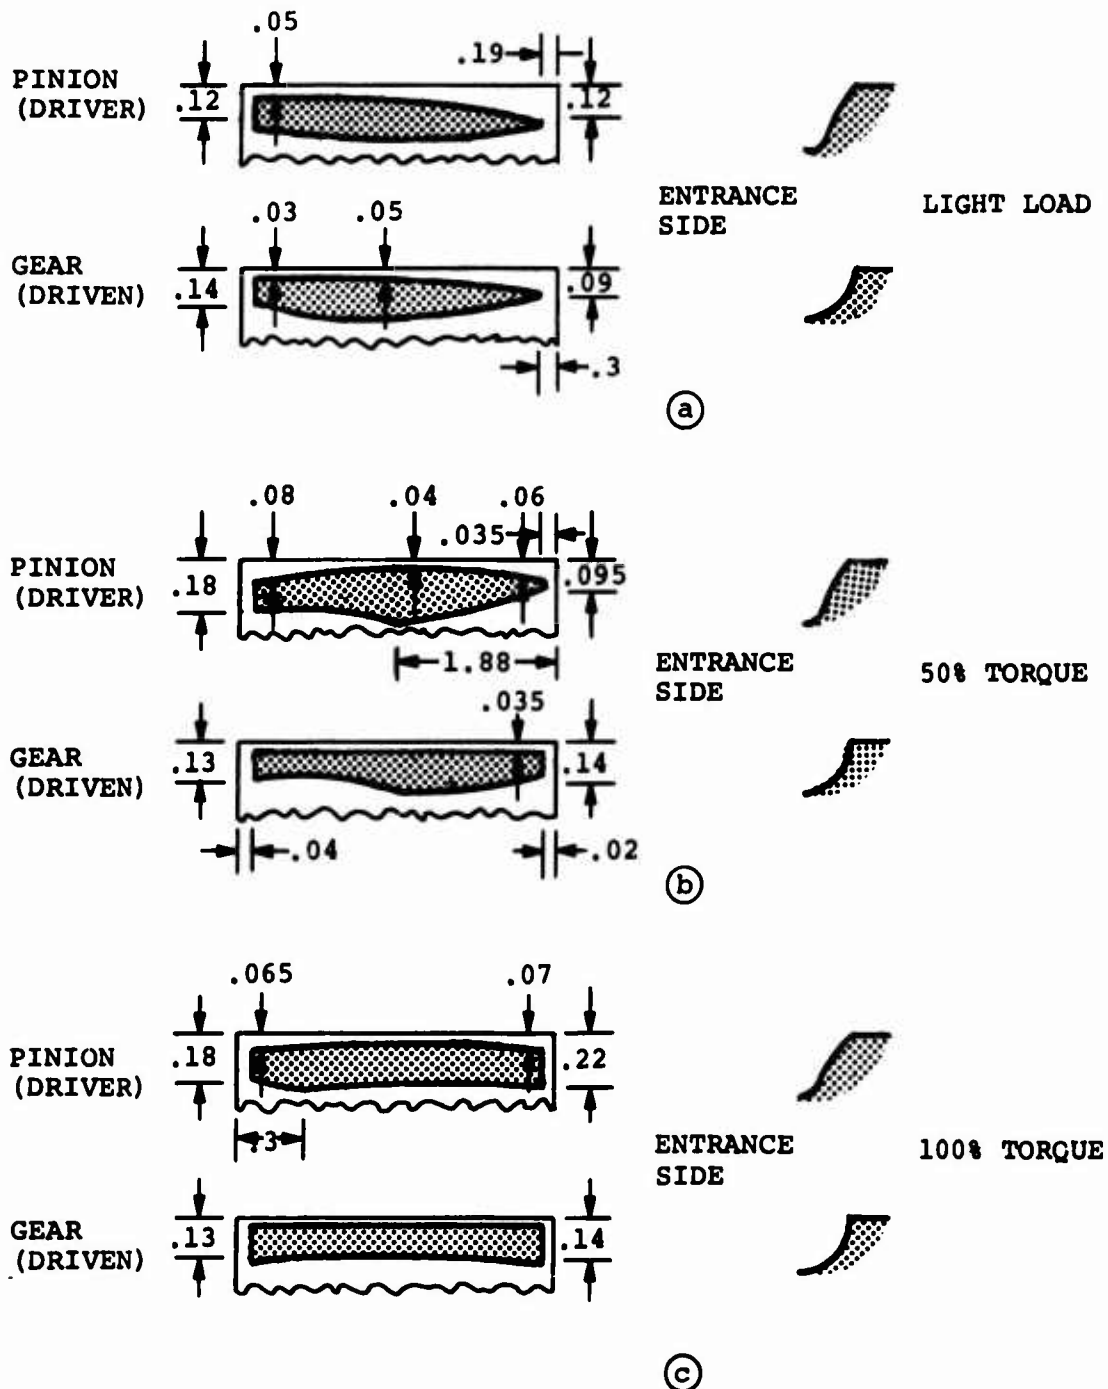
Figure 18. Static Gear Patterns - Gear Set No. 2.

Static pattern checks at the various load levels indicated a tapered pattern at both the entering and exiting ends (see Figure 18). At the 100-percent load level, this condition was not as evident as the result at the lower load level. The pattern on the gear member moved out to the break edge at the outside diameter at the higher load levels. Visual inspection after the initial run-in (50 percent of the design load) revealed very light scoring on both pinion and gear members (Figure 19a).

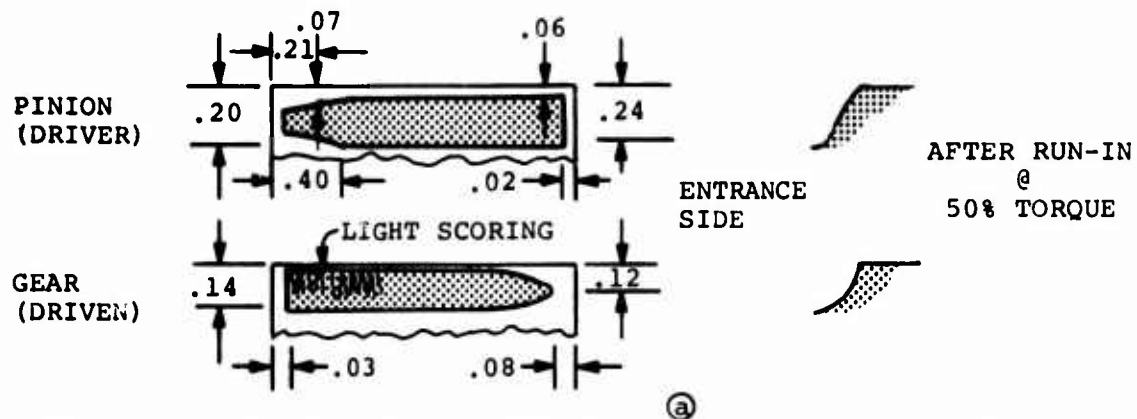
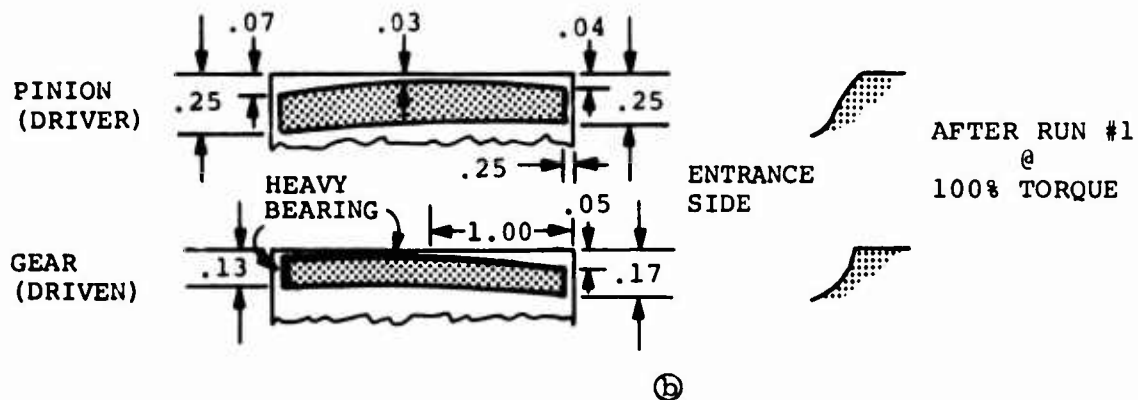
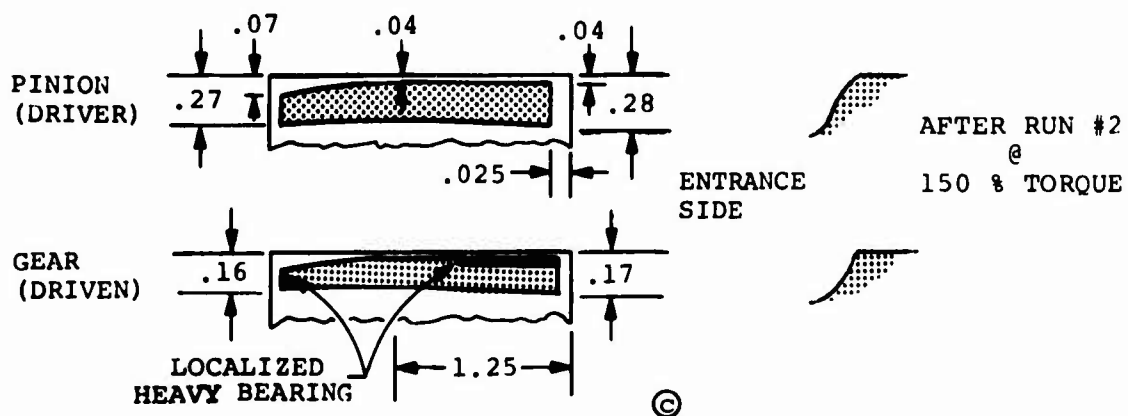
Figure 19. Gear Patterns After Running - Gear Set No. 2.

Run number 1 was completed at 100 percent of the design load for 6 million pinion cycles. Visual inspection upon completion of this run revealed a slight progression in the scoring condition at the completion of the 4-hour run-in. Some improvement in the tooth pattern was noted. The taper at the entrance and exiting ends was not as pronounced. There was a small, heavy bearing area at the exit end of the gear member, approximately 0.3 inch wide, running vertically along the tooth flank (Figure 19b).

Run number 2 was completed at 150 percent of the design load for 6 million pinion cycles. Visual inspection upon completion of this run revealed a slight improvement in the scoring condition (healing over). On the gear member, there was an indication of a secondary local heavier bearing within the original pattern at the entrance end of mesh (Figure 19c).

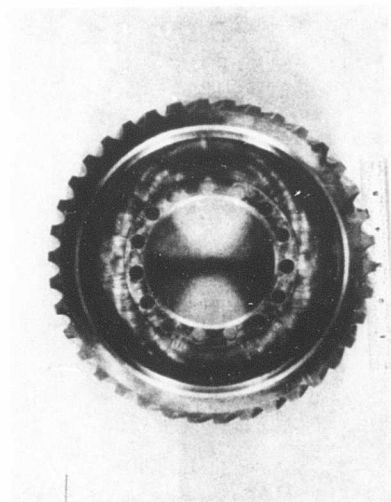
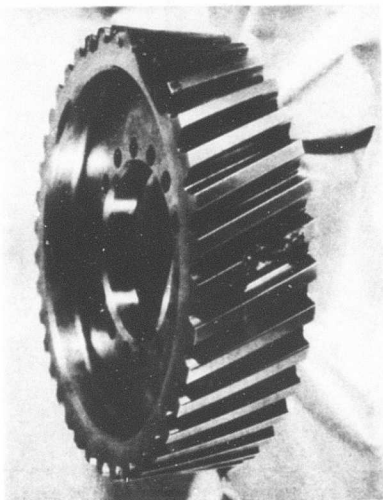
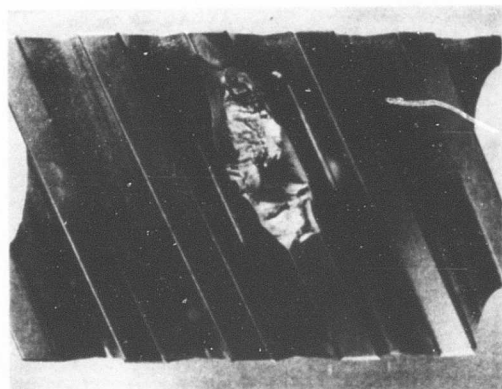
Figure 23. Fractured Face of Gear Set No. 1.

A fractographic examination of the failed tooth of gear member set number 1 located the origin of fatigue to be on the drive side of the fillet. The failure origin was located on the surface approximately at the juncture of the profile radius and the undercut.

Run number 3 was conducted at 175 percent of the design load level. This test run was terminated at 3,623,400 pinion cycles, due to bending failure of one tooth on the gear member. Subsequent Magnaglo inspection of this gear member did not reveal any other teeth with failure indications. Vertical scratches on every other tooth profile of the pinion members (in the first inch of face width) were attributed to the tooth failure on the gear member. Magnaglo

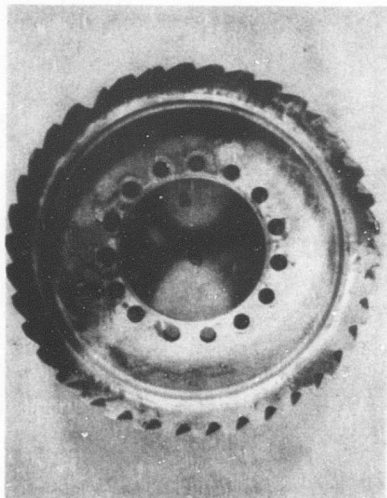
Figure 25. Conformal Gear (SK16207-4) - Set No. 2.

Run number 3 was conducted at 175 percent of the design load level and was terminated at 2,986,560 pinion cycles, due to a bending failure of one tooth on the gear member.

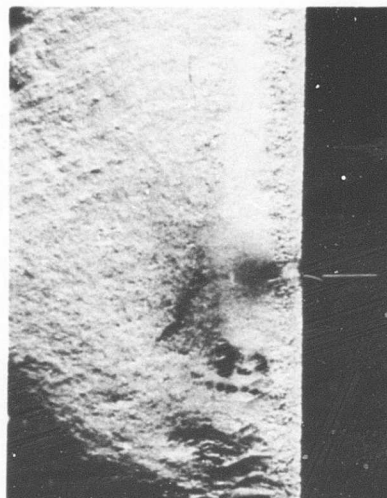
Figure 27. Fractured Face of Conformal Gear - Set No. 2. (Arrow Indicates Subsurface Origin.)

A fractographic examination of the failed tooth on the gear member of set number 2 also located the origin of fatigue on the drive side of the fillet. The origin was subsurface, approximately 0.042 inch below the junction of the profile radius and the undercut, and 0.008 inch below the surface (Figure 33).

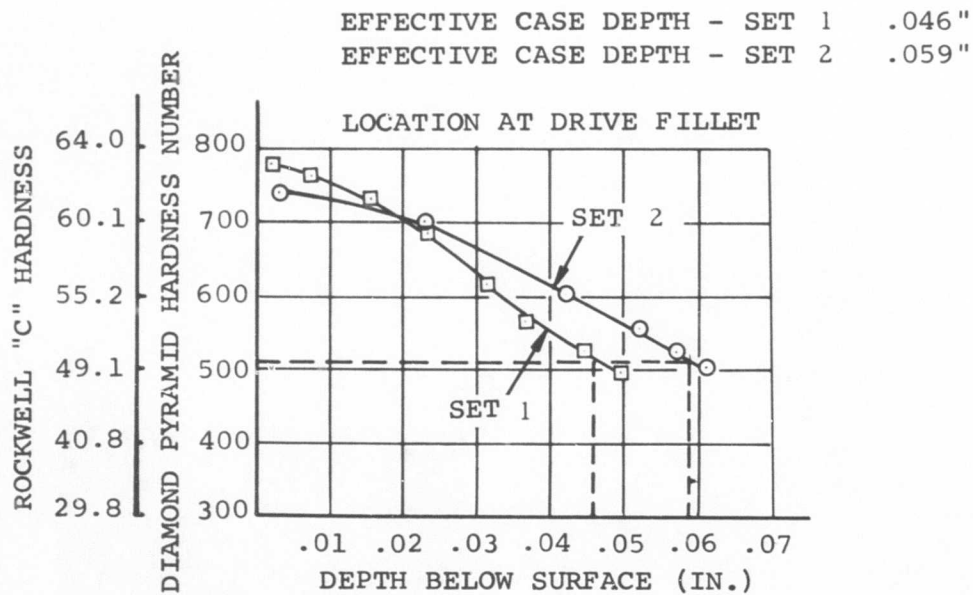
Figure 32. Graphical Analysis of Gear Sets Nos. 1 and 2 for Effective Case Depth Evaluation.

A microhardness traverse was made on the failed tooth of the gear member of both sets. The results are plotted in Figure 32. The effective case depth of the gear from set number 2 was 0.014 inch over the drawing specifications.
